Current Status of SPOL-Blue

2017-09-25

Manufacture Result

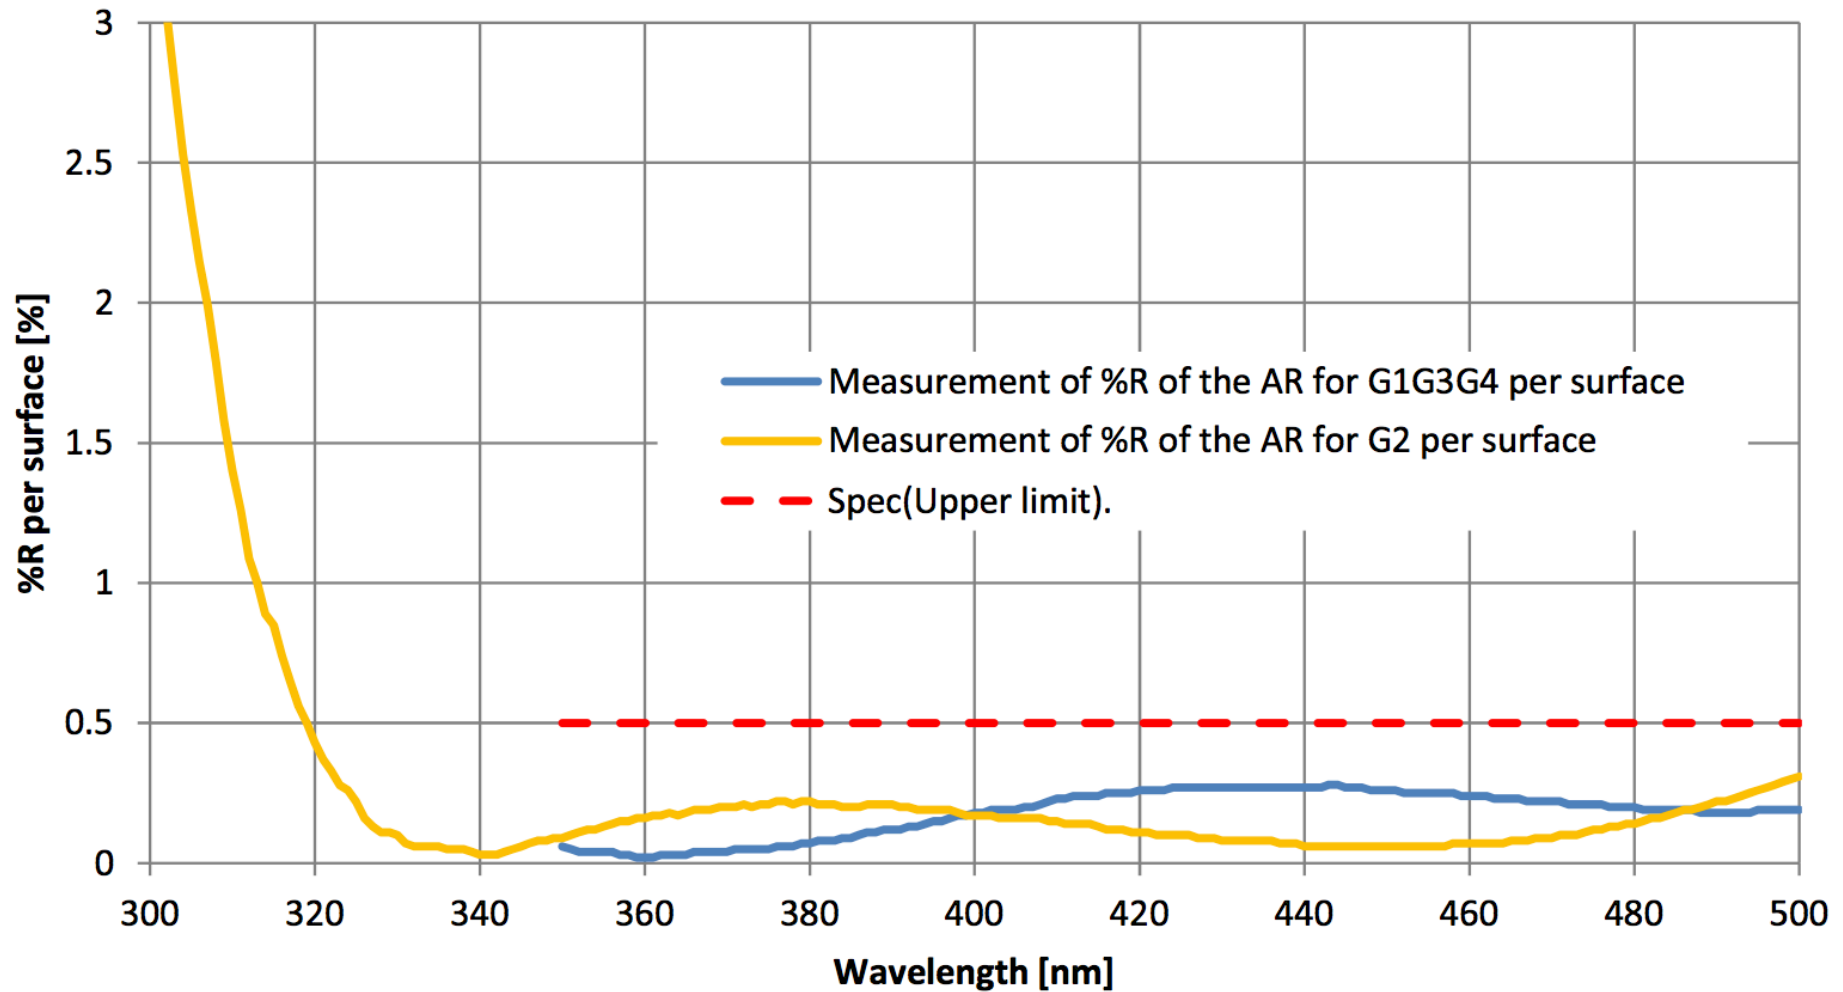
Reflectance of AR coat for lens in SPOL-MMT

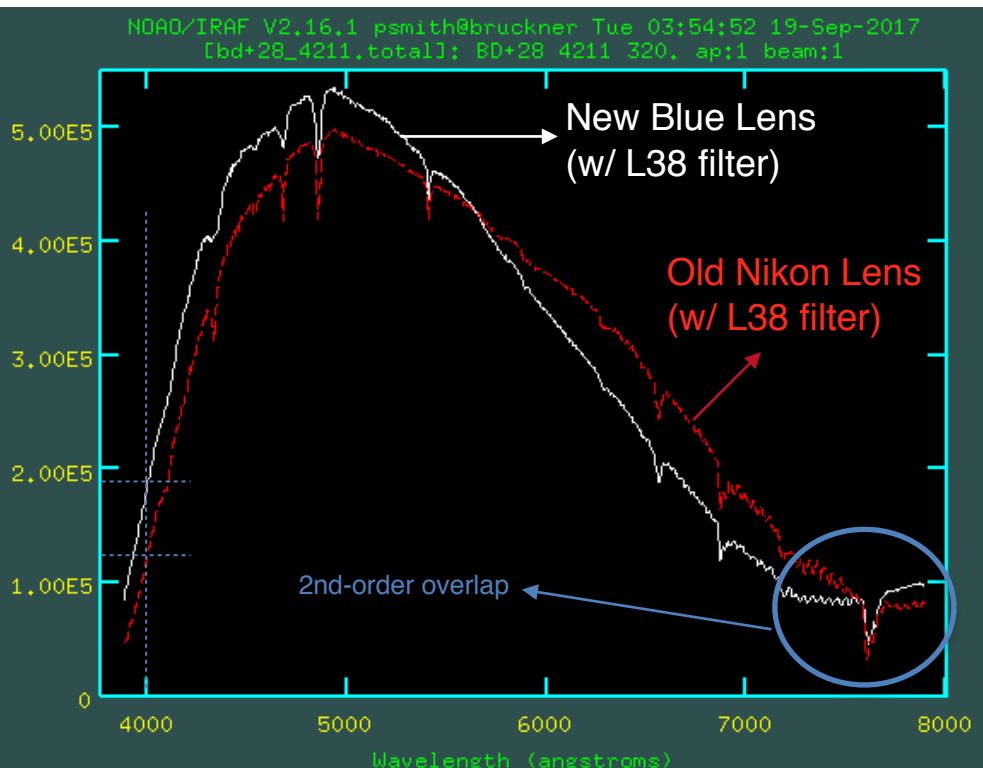
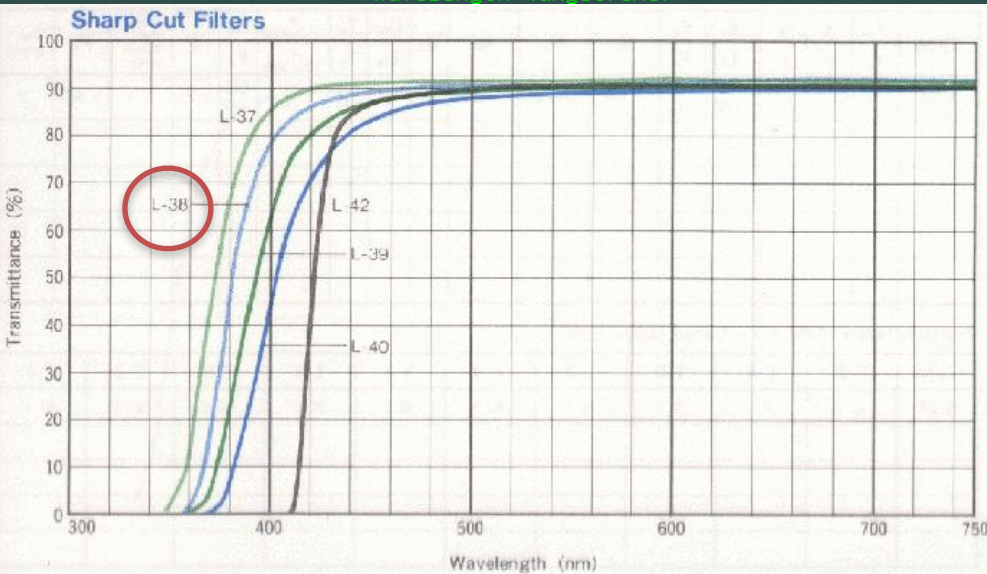
First Light - Lens #1 (2017-09-18 @61-inch)

< Blue Sensitivity Comparison >

- Object: BD+28 4211 (standard star)
- Spectro-polarimetric mode
 - grating: 600 l/mm
 - blocking filter: L38
- Note the 2nd-order overlap at $\lambda > 7200\text{\AA}$ for the new lens, indicating that much more $\lambda > 3600\text{\AA}$ light is making it through the new lens compared to the old.

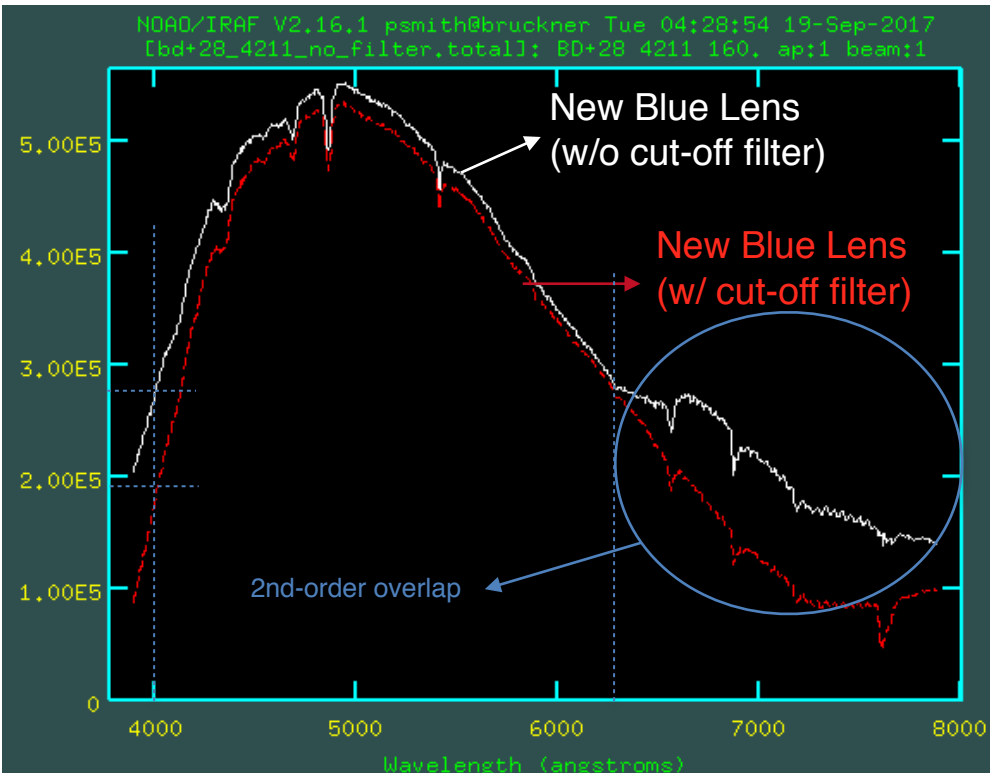
First Light - Lens #1 (2017-09-18 @61-inch)

< Blue Sensitivity Comparison >

- Object: BD+28 4211 (standard star)
- Spectro-polarimetric mode
 - grating: 600 l/mm
 - blocking filter: (red curve): w/ L38 & (white curve): w/o L38
- Notice the ADU number at the blue end of the spectrum. Also, note that the 2nd-order overlap begins at $\lambda \sim 6400\text{\AA}$, indicating the instrument is detecting photons right down to the atmospheric UV cutoff of $\lambda \sim 3200\text{\AA}$.

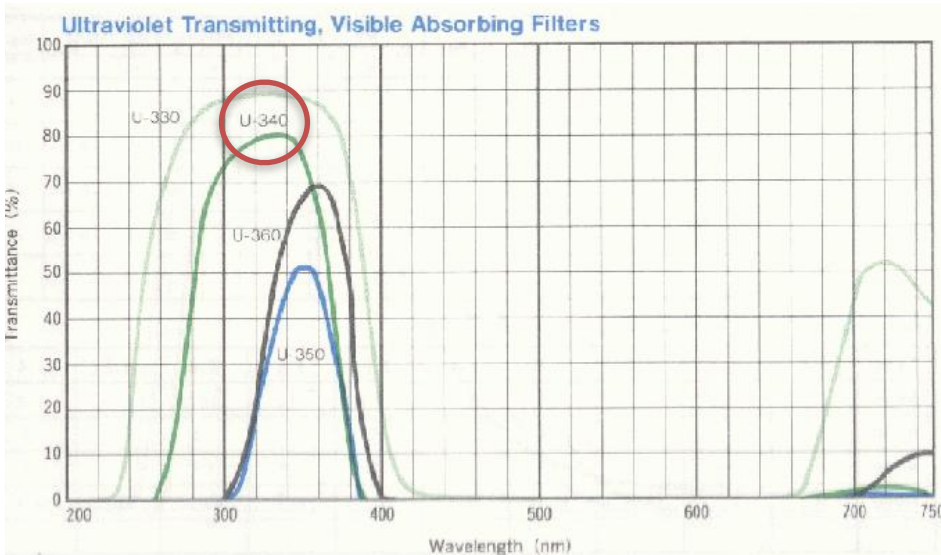
Blue Sensitivity Comparison (2017-09-19 @61-inch)

< Blue Sensitivity Comparison (Blue Lens #1 vs. Nikon) >

- Object: BD+28 4211 (standard star)
- Spectro-polarimetric mode
 - grating: 600 l/mm (not blue grating)
- With U340 filter, the blue lens sensitivity is ~40 times higher than the Nikon.
- With B390 filter, the blue lens sensitivity is ~1.04 times higher than the Nikon (4% higher).
- **In $\lambda < 4000\text{\AA}$, the new blue lens is much higher sensitive than the original Nikon lens. However, in $\lambda > 4000\text{\AA}$, two lenses show similar amounts.**
 - **Even if the grating used is not optimal at blue region and the wavelength of two filters are partially overlapped, it is interesting to see the 40x sensitive!**

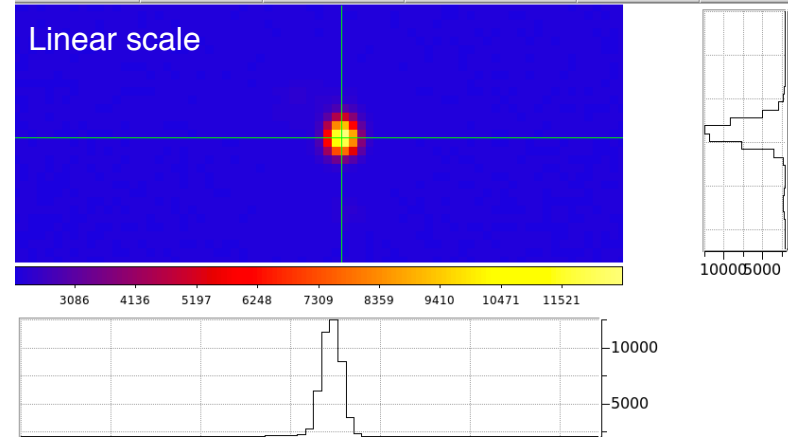
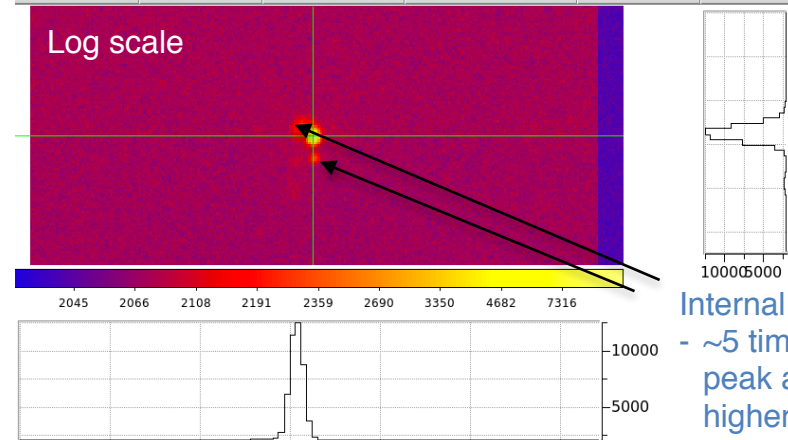
PSF Measurement (2017-09-20 @61-inch)

< PSF Profile (Blue Lens #1) >

- Filter: U340
- Object
 - “blue light projected on the dome” with pinhole located at the Cassegrain focus
- Raw data: “cc015.fit”

Internal reflection (weak)?
 - ~5 times less than main peak and ~1.1 times higher than background

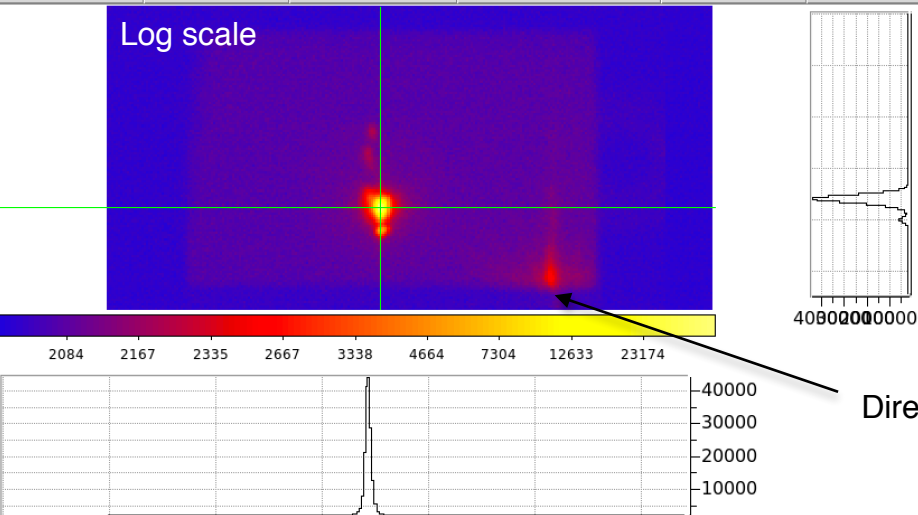
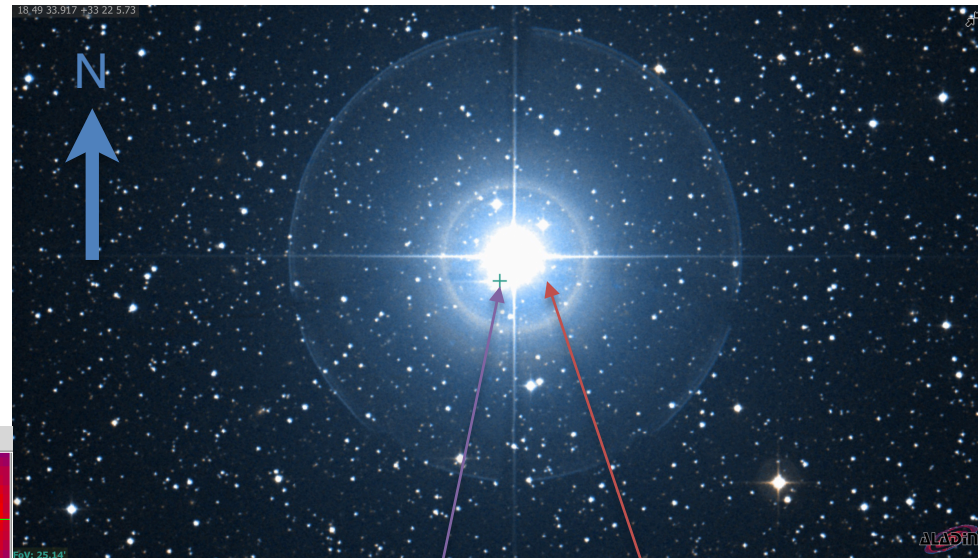
PSF Measurement (2017-09-20 @61-inch)

< PSF Profile (Blue Lens #1) >

- Filter: U340
- Object: β Lyr B
- Seeing: 1.6 ~ 1.7 arcsec (measured at red)
- Raw data: "cc016.fit" ~ "cc030.fit" (at various fields)

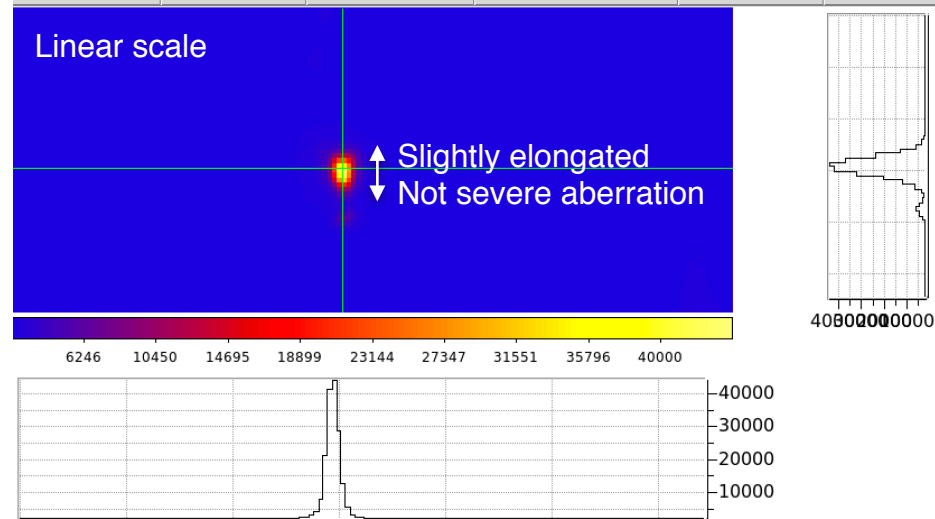
PSF Measurement (2017-09-20 @61-inch)

< PSF Profile (Blue Lens #1) >

- Filter: U340
- Object: β Lyr B
- Seeing: 1.6 ~ 1.7 arcsec (measured at red)
- Raw data: "cc016.fit" (near center & slightly lower)

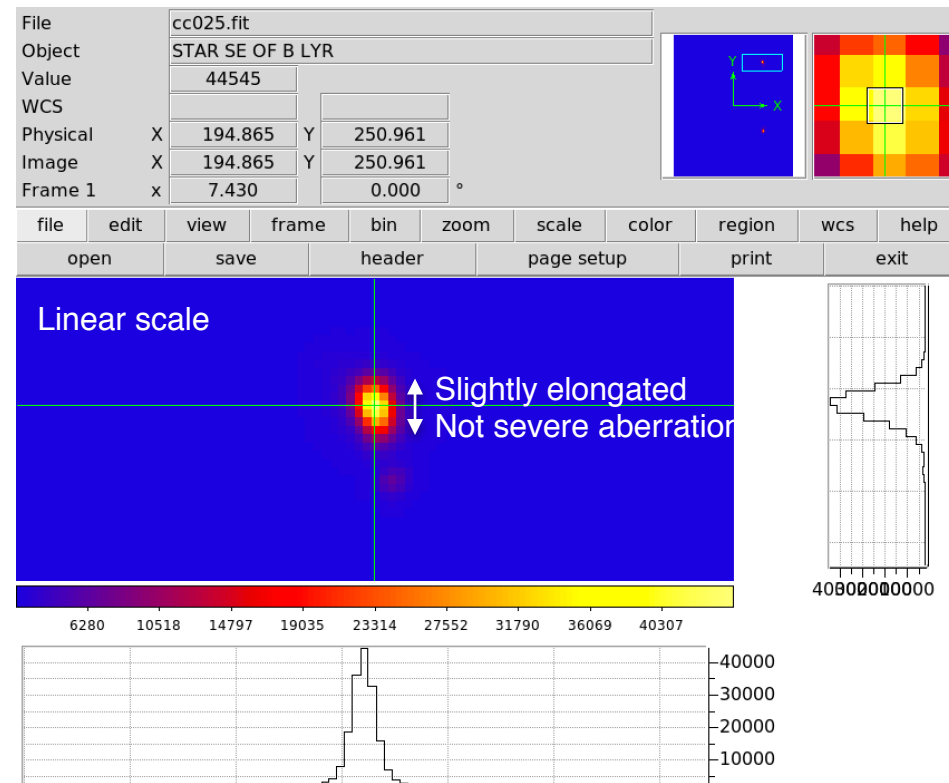
PSF Measurement (2017-09-20 @61-inch)

< PSF Profile (Blue Lens #1) >

- Filter: U340
- Object: β Lyr B
- Seeing: 1.6 ~ 1.7 arcsec (measured at red)
- Raw data: "cc025.fit" (upper right)
